**Enniscorthy Castle, County Wexford**  
**Report on 'The Halberdier Wall Painting'**

*A Heritage Council Funded Project (R02574)*

**Rory Sherlock MA PhD MIAI**  
Consultant Archaeologist

October 2012

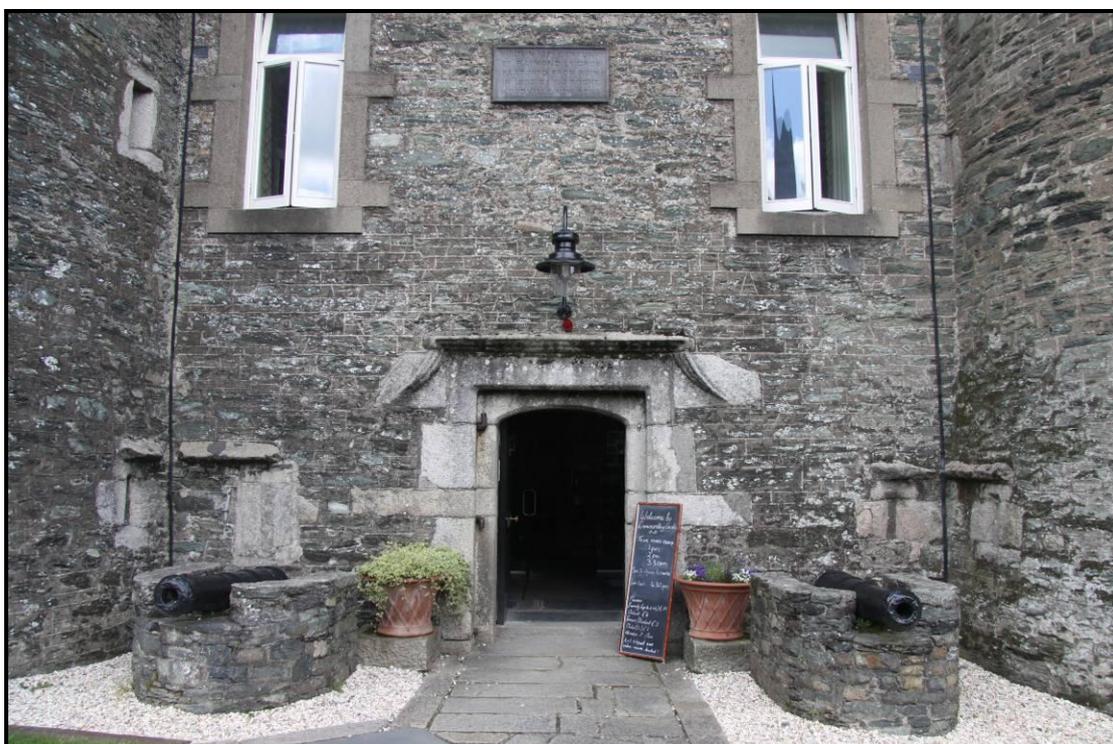
**Plate 2:** Enniscorthy Castle doorway with hood moulding, yett hinges and flanking loops.

In short, the surviving architectural details in the building, including the entrance doorway (Plate 2), the windows and the ground-floor fireplace all appear likely to date to the sixteenth century and since none are clearly inserted into an earlier structure, then one must conclude that the building is generally dateable to the sixteenth century, though it is possible that it was built on the site of, and perhaps on the footprint of, the earlier castle.

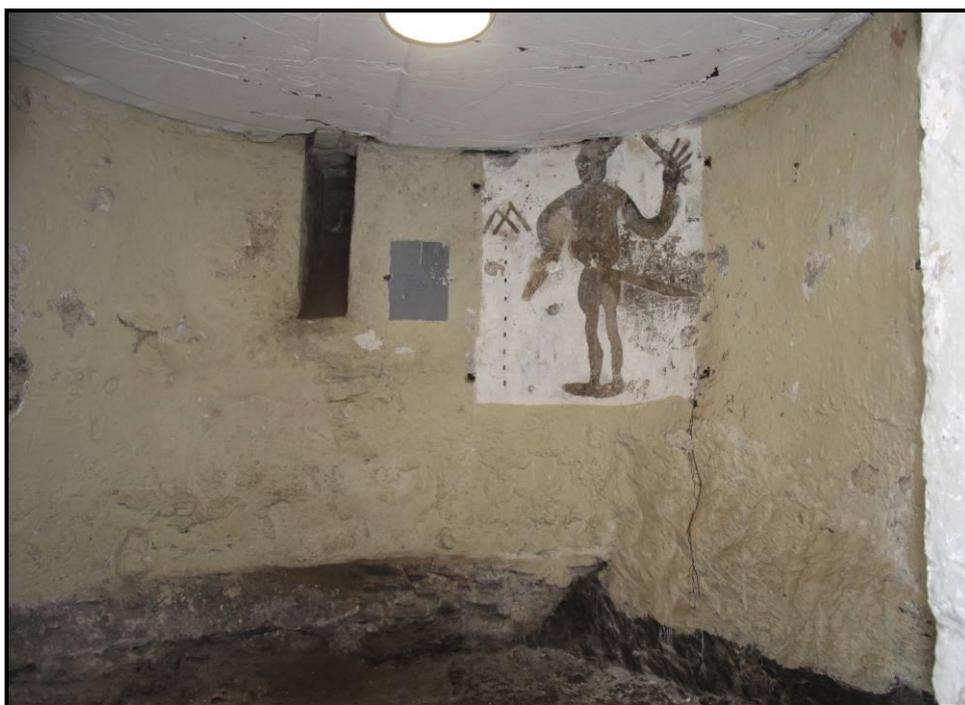
The removal of the large heating boiler in recent years led to the 're-discovery' of a figure on the wall of the inner basement room (Plate 3) which had been recorded by Herbert Hore (1817-1865) in the nineteenth century and later described in print when Hore's son, Philip Hore, published his father's research in the *History of the Town and County of Wexford* in six volumes between 1900 and 1911.

**Plate 3:** The 'Enniscorthy Halberdier' in the inner chamber of the basement; note the bedrock below the figure to the right and the modern concrete ceiling above it.

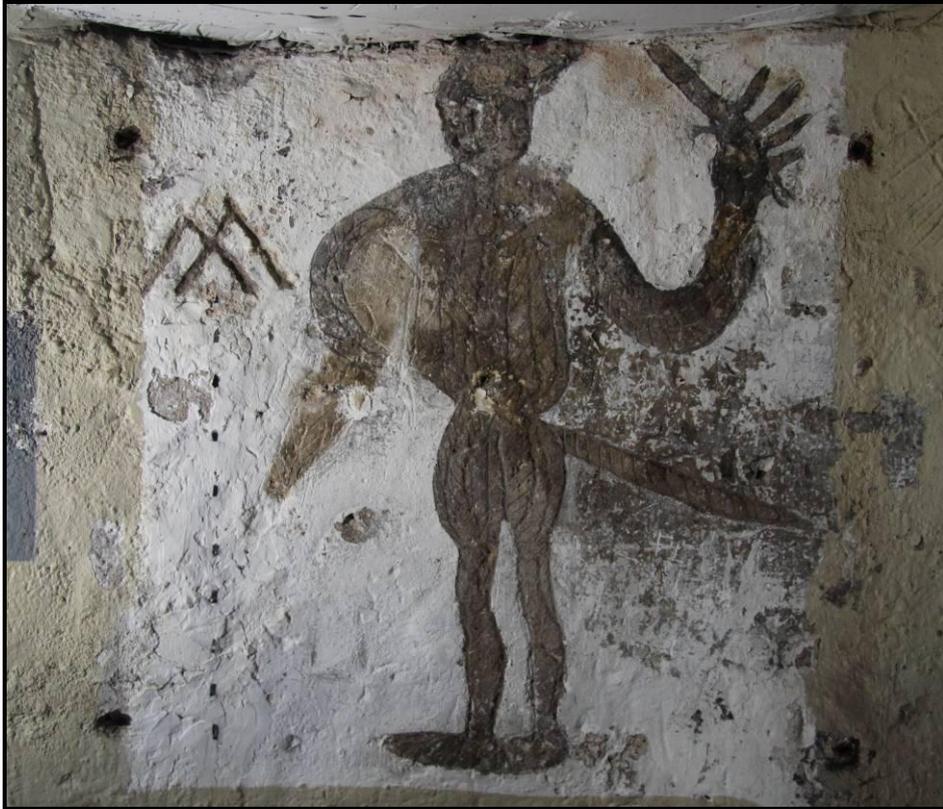
The figure has clearly suffered somewhat since Hore recorded it and the insertion of the concrete ceiling in modern times appears to have truncated the uppermost portion of his head and may have caused two deep marks in the facial area also. The figure is deeply incised into the lime render on the wall, but some small repairs have been made in modern times using gypsum-based materials. The room has also been painted relatively recently, but a square area around the figure was left untouched by this work and so the older whitewash is visible in this area, though this whitewash in turn was not applied to the figure itself. This process has caused the figure to appear to be a wall painting, since it stands out as beige/brown/red figure against a white 'background', but on closer inspection this is found to be false - the figure was clearly

created by using a sharp implement to cut lines into the existing plasterwork and no clear evidence for figurative painting has been noted.

**Plate 4:** The 'Enniscorthy Halberdier'

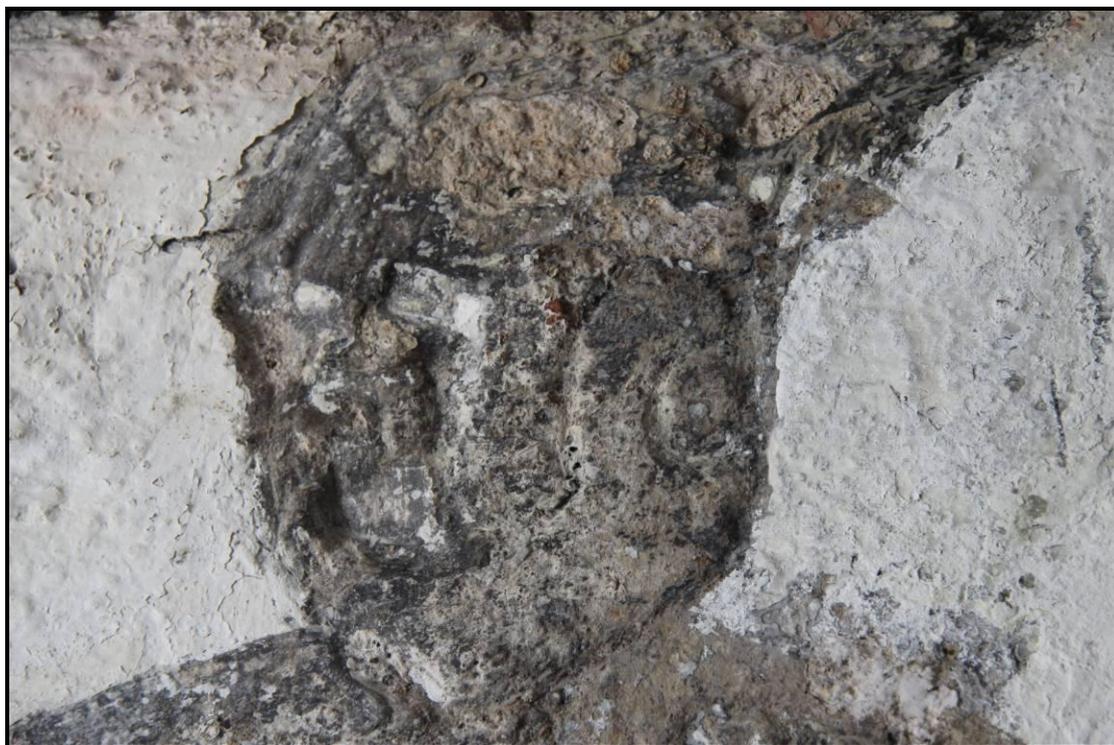
**Plate 5:** The head of the figure

The head of the figure is crudely represented, though the nose and the left eye are clearly visible. The right-hand side of the face appears to have suffered some damage, possibly during the insertion of the concrete ceiling above, and the top of the head has been truncated so it is now unclear if the figure was wearing a hat.

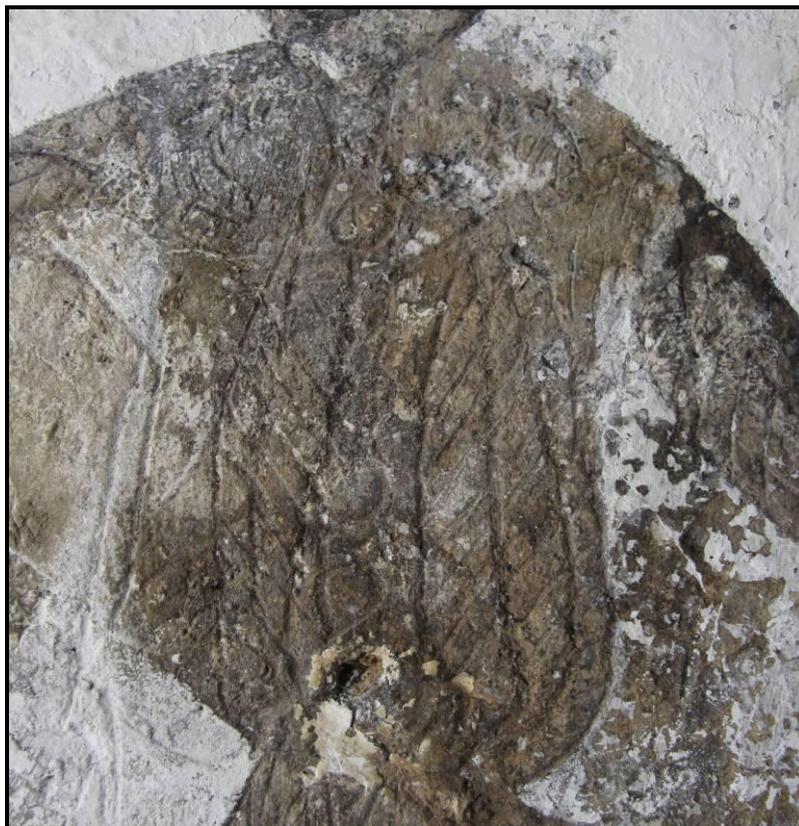
The torso of the figure appears to be clothed in a jacket or doublet which features a central line of buttons and is defined by a series of vertical panels filled with diagonal hatching. A series of very fine vertical lines in the clavicle area at the top of the doublet are notable since they are quite different to the deeper, coarser incisions used in the remainder of the figure. They may represent a collar or other decorative element of the doublet, but are somewhat difficult to interpret and suffer from damage on the figure's left-hand side.

**Plate 6:** The torso of the figure

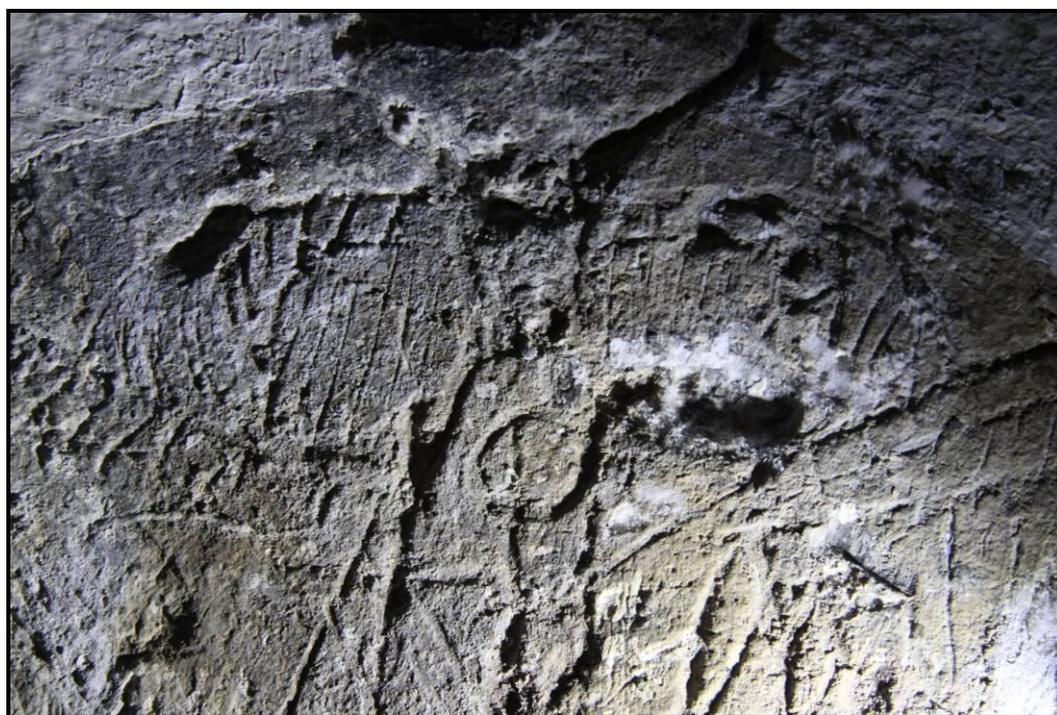
**Plate 7:** The fine lines at top of the figure's torso (centre)

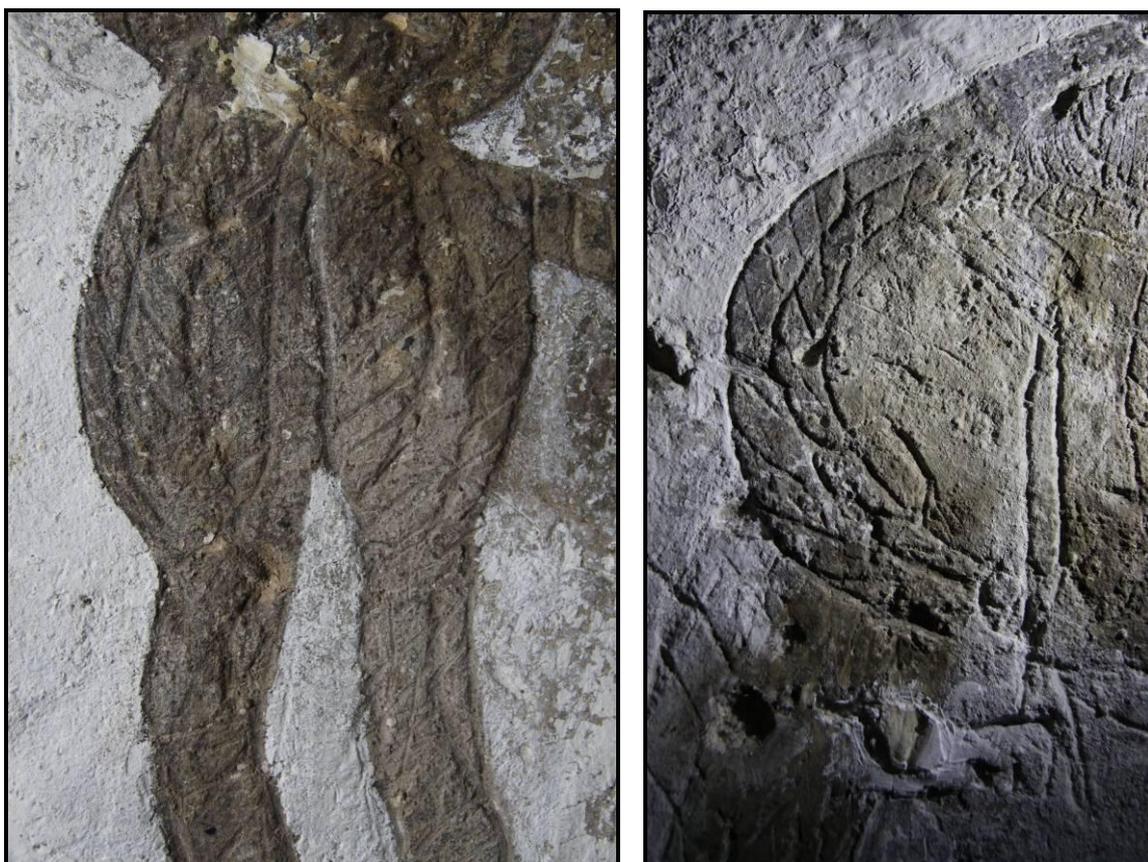
The limbs of the figure are represented quite simply, though the legs are defined more clearly than the arms. The arms simply bend in continuous arcs with no attempt being made to represent the elbows (Plate 9), while the legs are more carefully represented with broader thighs giving way to slender knees and calves (Fig. 8). This may be a representation of trousers which are loose fitting above the knee and close fitting below it, but this is difficult to establish with certainty.

**Plate 8:** The legs of the figure (left) and the right arm of the figure (right)

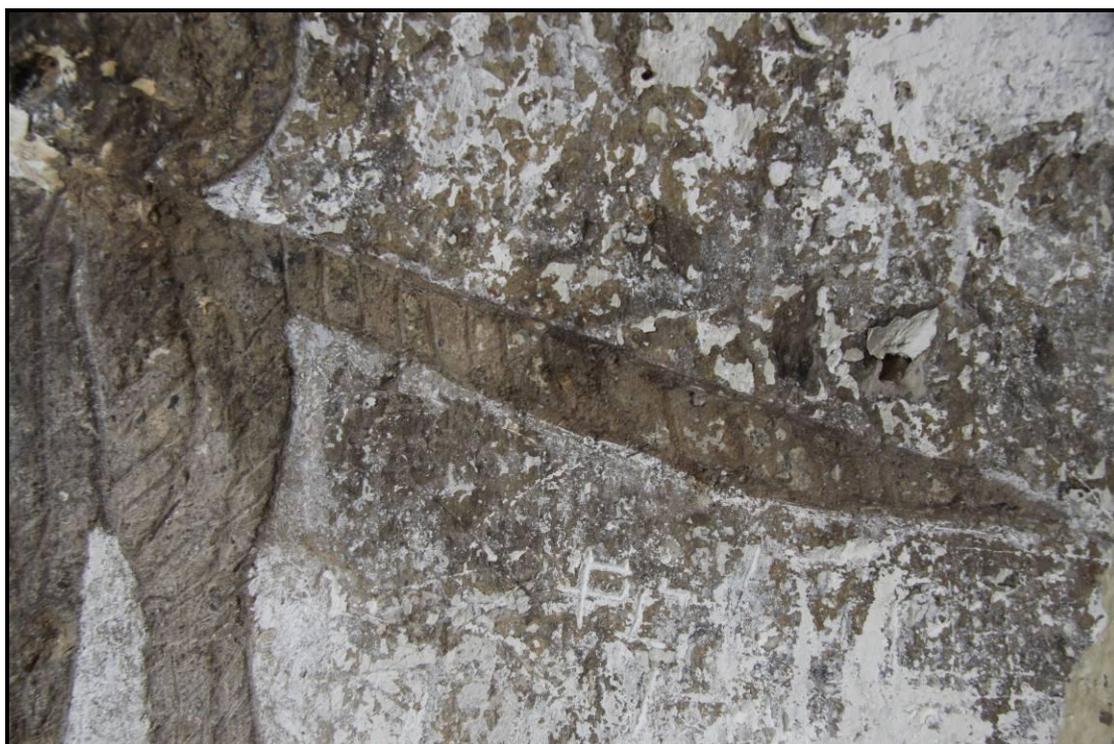
In addition to the figure itself, one should also note the presence of other features such as the scabbard and the short sword or dagger held aloft in the figure's left hand. The scabbard (or perhaps an unsheathed sword) is depicted simply with an incised outline and hatched interior; the upper and lower edges run parallel to each other for most of the object's length before the lower edge turns upwards to meet the upper edge at the tip. The short sword or dagger held in the figure's left hand is not depicted with any detail and so is difficult to discuss, though it is interesting to note that the figure's left hand is depicted as being open instead of closed around the handle.

**Plate 9:** The scabbard or long sword

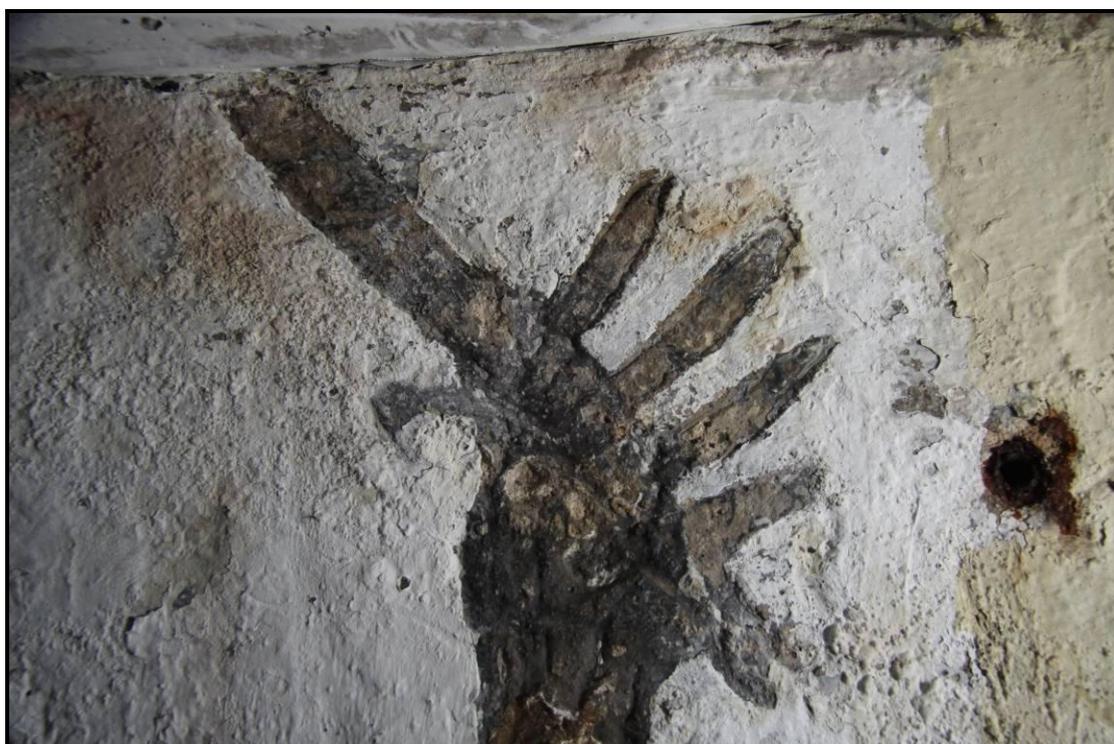
**Plate 10:** The short sword of dagger in the figure's left hand

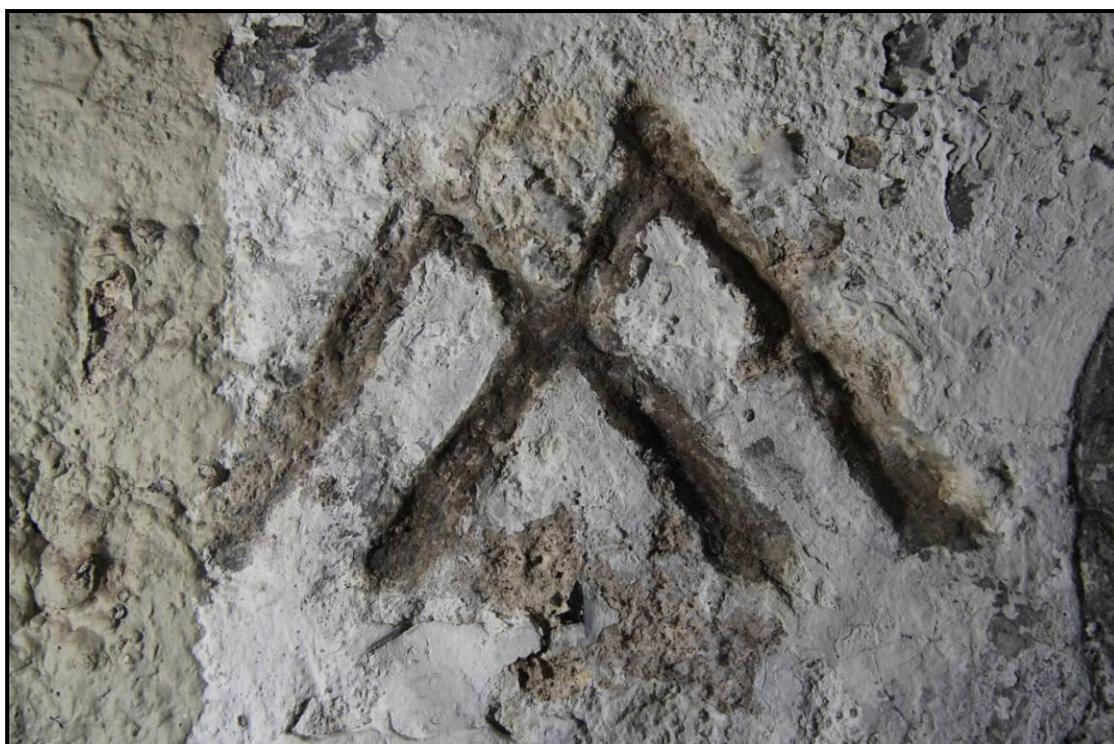
To the left of the figure is an incised motif which appears to be composed of two interlocking arrows or triangles and so resembles a letter 'M'. It is unclear if this motif forms part of the same composition as the figure of the swordsman, but a specialist on medieval graffiti in England, Matthew Champion, in communications with Kieran Costello of Enniscorthy Castle, described it as an apotropaic motif (i.e. designed to ward off evil) associated with the Virgin Mary and noted that hundreds had been found in England (pers. comm. K. Costello).

**Plate 11:** The 'M' to the left of the figure

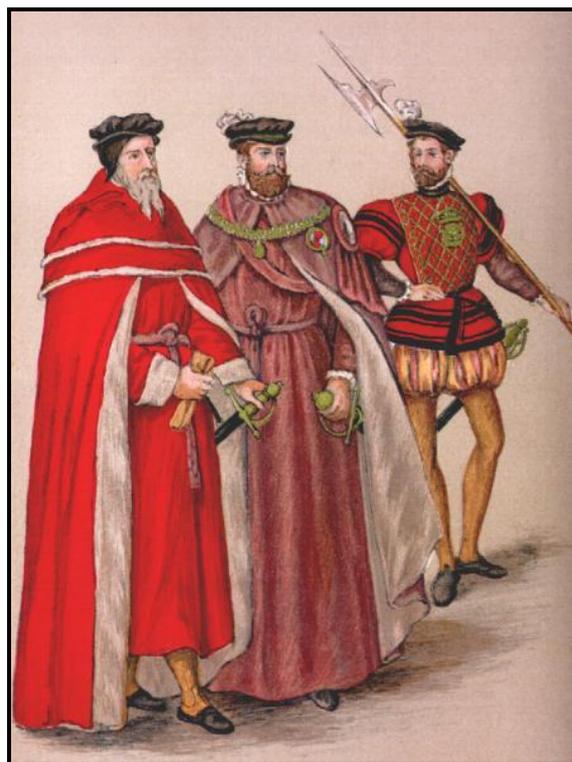
**Plate 12:** *Two Peers of the Realm and a Halberdier*  
(© British Library)

A halberd is a form of pole-arm which features a three-part head mounted on a long handle, the head being composed of an axe-like blade on the leading edge, a hook on the rearward edge and a spike on the top. The weapon was generally five to six feet in length and was used by foot soldiers against mounted opponents in many European armies in the late medieval and post-medieval periods. In his published description of the figure, Hore cast doubt on his own suggestion that it was a representation of a halberdier and this was, perhaps, a prudent assessment of the evidence. The

Enniscorthy figure is best described as a swordsman, though the possible existence of an ill-defined object in the angle of his right arm, which also appears to taper downwards below the arm, makes the true role of the figure difficult to assess.

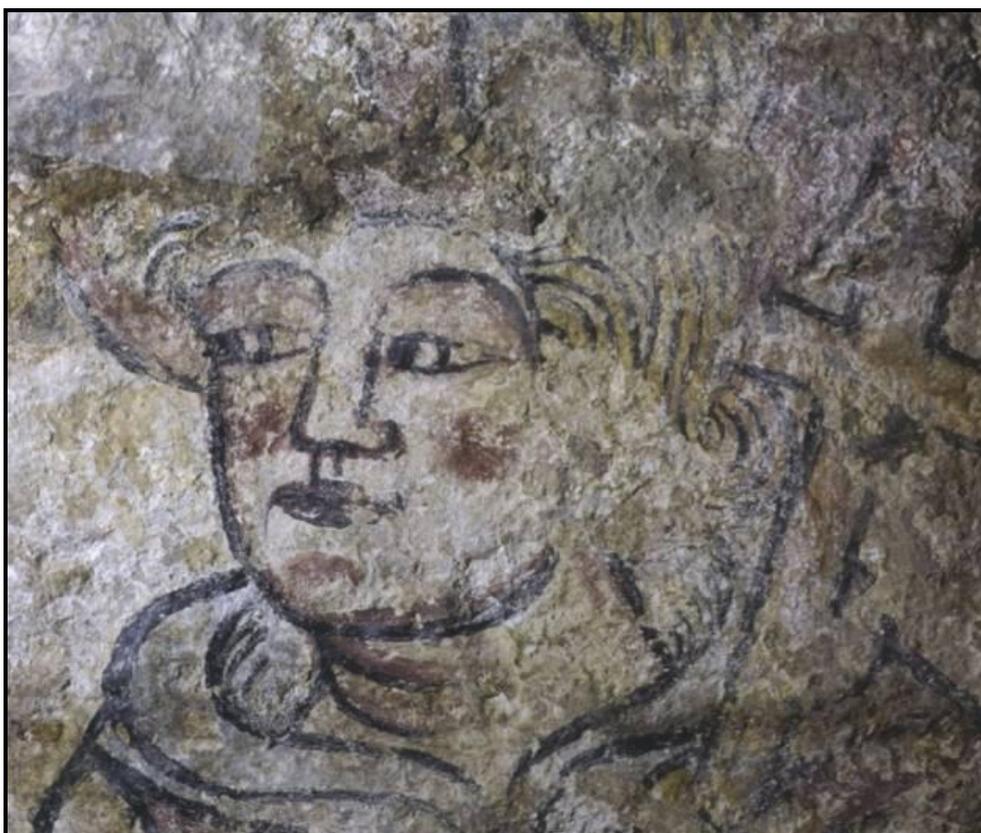
**Plate 13:** St Thomas Beckett at Ballyportry Castle, Co. Clare (after Morton 2012, Fig 6, 99)

these are ecclesiastical foundations, a total of nine castles are also included in this group (Morton 2010, 98). Morton describes the imagery at two castles as follows: *'The extensive paintings in Ardamullivan Castle ... depict scenes from the Passion of Christ together with images of St Michael Weighing the Souls, St Christopher and the Christ Child and an ecclesiast, probably Bishop Colman, while those in Ballyportry Castle ... depict the Martyrdom of St Sebastian and St Thomas Beckett among other imagery'* (Morton 2010, 98).

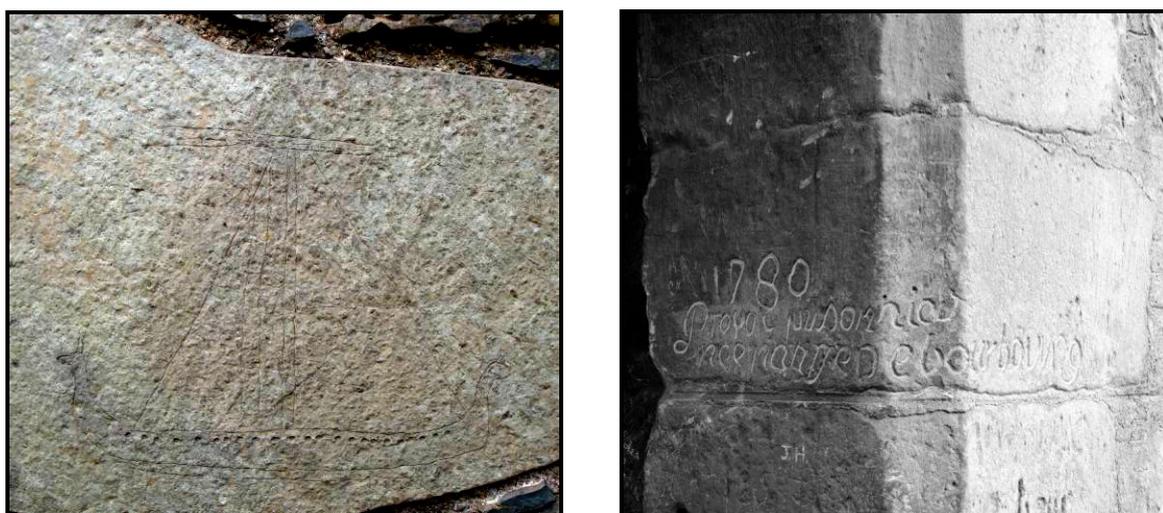
**Plate 14:** Ship graffiti at Duluce Castle (left) and prisoner graffiti at Edinburgh Castle (right) (photo: Canmore ©RCAHMS)

4.2.2 Graffiti in Irish castles has received less attention in academic research than wall paintings, and the full extent of pre-modern graffiti in these buildings is unknown. Ship graffiti is, perhaps, the best known form of graffiti in medieval buildings and the example from Dunluce, Co. Antrim (Farrell 1978) has been documented by a number of authors. Ship graffiti are known also from ecclesiastical contexts and the Norfolk Medieval Graffiti Survey has recorded numerous incised ship motifs in parish churches at Blakeney and Wiveton, amongst others (Norfolk Medieval Graffiti Survey 2012).

Prisoner graffiti is another area that has received some academic attention in recent years, most notably at Edinburgh Castle, Scotland, where extensive traces of prisoner graffiti were discovered, recorded and made accessible to the public. Dating to the eighteenth and nineteenth centuries, this graffiti is incised into both wood and stone, though it is largely composed of inscriptions or small motifs and large, figurative representations are not present.

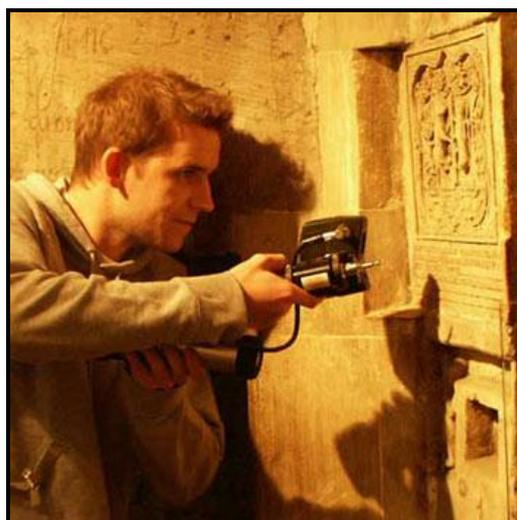
**Plate 15:** Handheld laser scanner in use in survey of medieval graffiti in the Tower of London ([www.liverpoolmuseums.org.uk](http://www.liverpoolmuseums.org.uk))
